# Development of Water Purification Equipment with RO Membrane for Mini-scale Water Supply Facilities

Haruo Hamano, co-author Yukio Fujita

Water Purification Business Division. SHIMIZU ALLOY MFG. CO., LTD

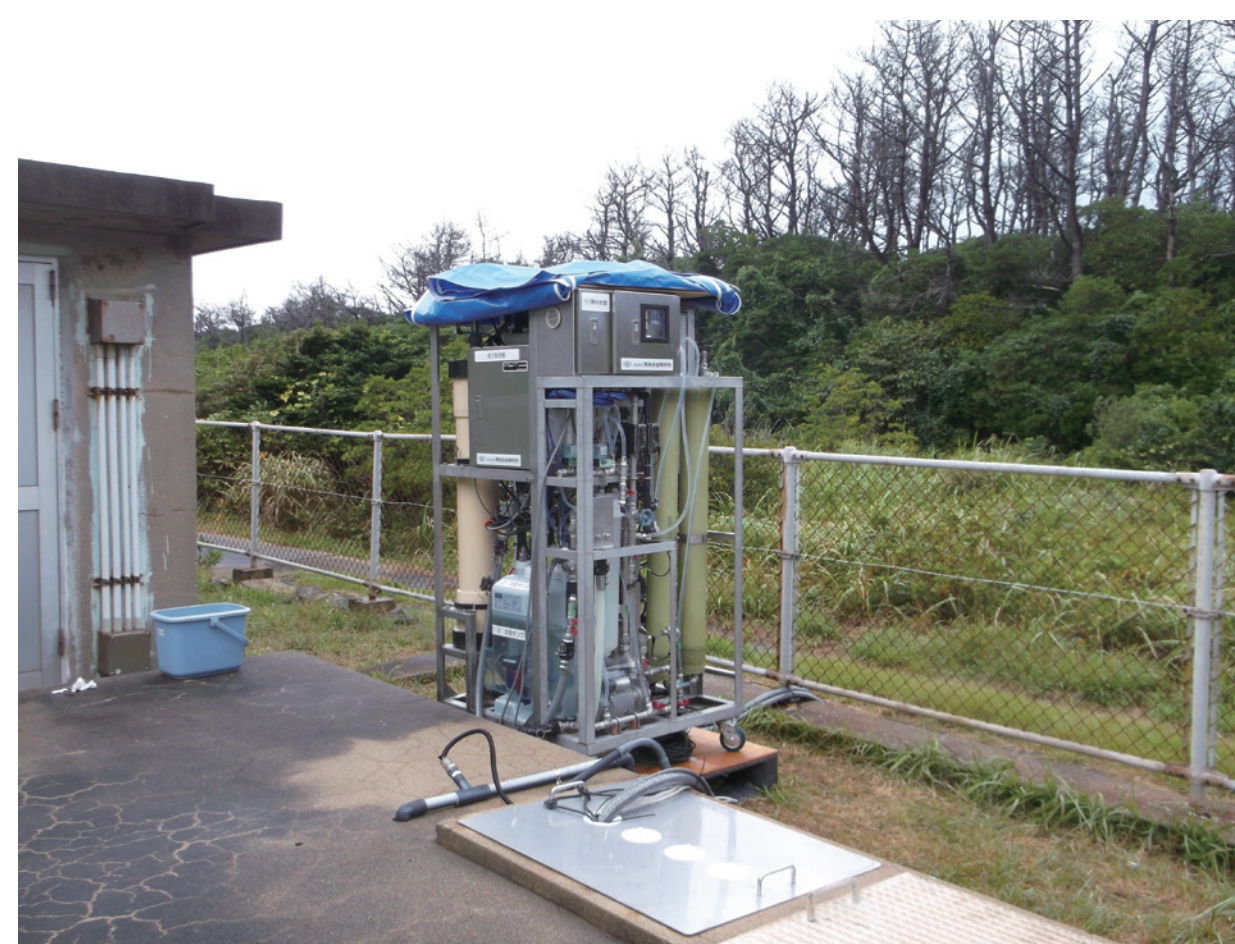
Fig. 3 Installation scenario

The installation scenario is shown in Fig. 3. The water treatment flow chart in field tests is shown in Fig. 4. The circumstance of the water resource are shown in Fig. 5. An enlarged view of Fig. 5 is shown in Fig. 6. The method of the field tests is shown in Table 1.

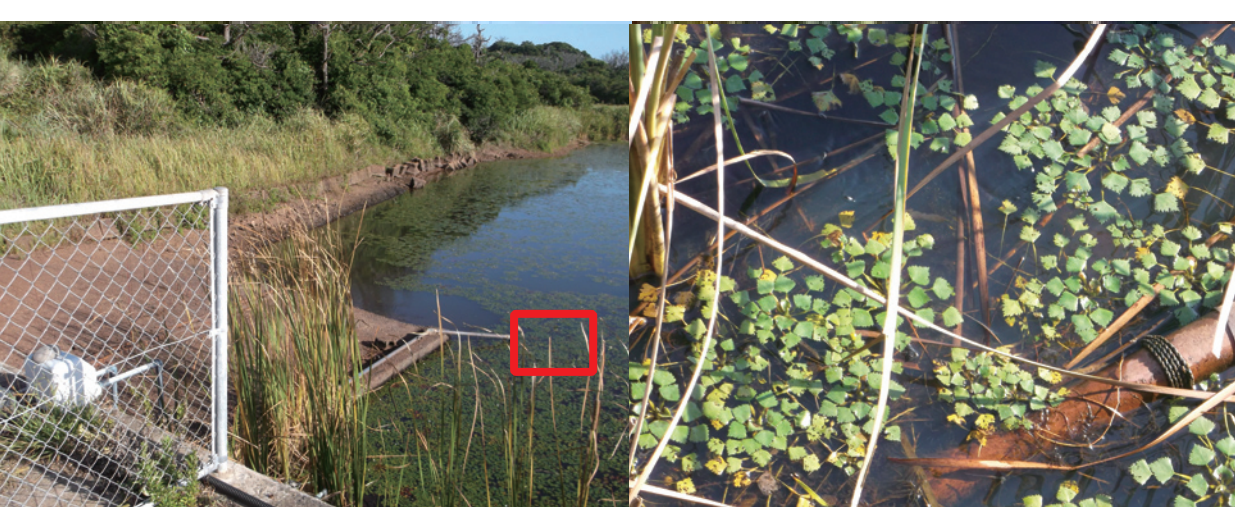
Fig. 5 Circumstance of water resource
